## EFFECT EVALUATION OF REPAIRING METHOD USING CFRP SHEET FOR STEEL GIRDER END

Nagaoka University of Technology

Structural Analysis Laboratory Galicia Garcia David

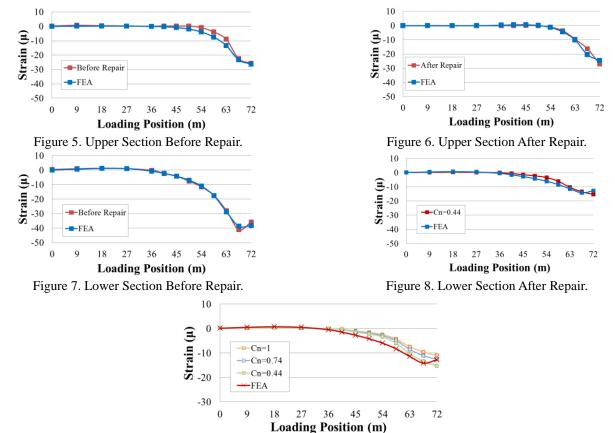
Figure 9. Strain Distribution after Repair for different  $C_n$  (Lower Section).

**B)** Strain Distribution (Lower Section): Since the strain gauges were attached above the CFRP sheets (after repair), it was necessary to consider a  $C_n$ . Firstly, the steel strain reduction was calculated considering the Cn used during the design procedure, this is 0.74. However, comparing this strain distribution with the one obtained from FE analysis, it was found that slightly bigger strains were obtained from the on-site measurements. A different value of Cn (=0.44) considering the development length (distance from corrosion area to the edge of the outermost CFRP sheet) and shift amount (distance between the ends of each carbon fiber sheet) of all the analyzed sections was calculated. The strain distribution for this value of Cn presented a good matching with the FE analysis, founding errors below 10% for cases where the load is near to the support A2, location of the

- 1. For the upper section, it is thought that no repair effect for this section was obtained (no CFRP sheets were bonded here).
- 2. For the lower section, it was found that the strain level was reduced in a range from 55~80%, with an averaged value of 69%, when  $C_n$ =0.44 was used. The strain reduction was 75% when a  $C_n$ =0.74 was considered.
