Numerical Simulation of Deterioration Process of Concrete Structures of Electric Power Facilities due to Chloride Attack

3. CASE STUDY: TOYOSU SERVICE TUNNEL

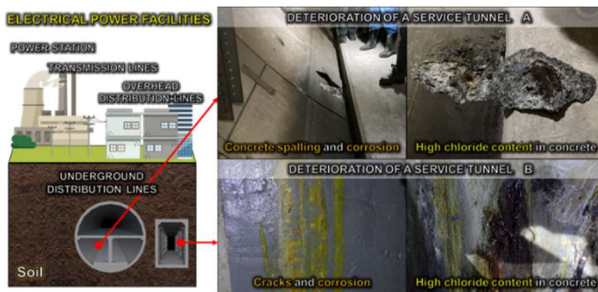
Fig. 1 Deterioration in Reinforced concrete service tunnels

Reinforced concrete electrical power facilities are critical infrastructure designed to generate, transmit, and distribute electricity. Recent inspections of underground service tunnels have revealed significant deterioration, including cracks, concrete spalling, and steel reinforcement corrosion.^[1] Investigations on the tunnels have confirmed high chloride content in the concrete of these facilities. (See Fig. 1)

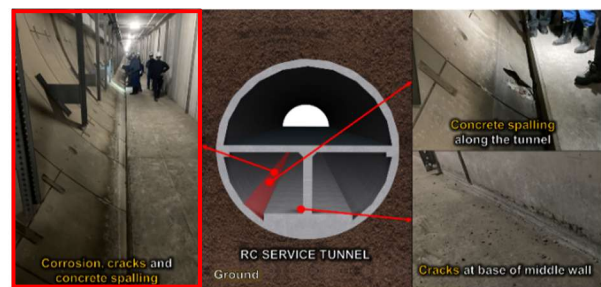
Fig. 3 Deterioration in the left section of the service tunnel

In July 2024, a visual inspection of the lower left section of the Toyosu service tunnel revealed multiple signs of deterioration in the reinforced concrete structure, including reinforcement corrosion and concrete spalling (see Fig. 3). The inspection covered a 0.6 km segment from the Shin-Toyosu Substation entrance in Tokyo.

This case study focuses on the lower left section of the tunnel, near a drainage system, where water infiltration marks were observed (highlighted in red in Fig. 3).

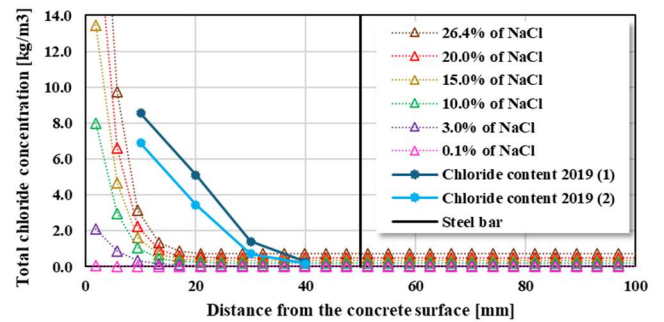
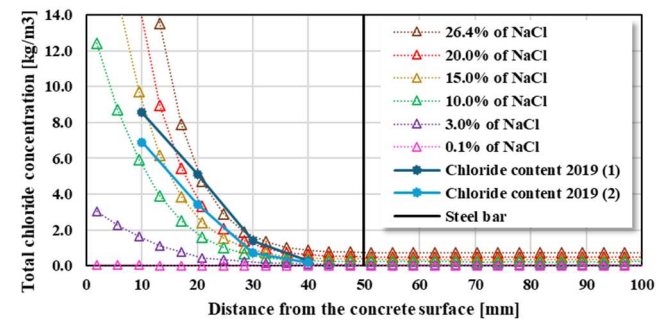
a) Chloride concentration profile (1 month)

b) Chloride concentration profile (6 months)

c) Chloride concentration profile (12 months)

d) Chloride concentration profile (18 months)

e) Chloride concentration profile (24 months)

Fig. 4 Test series under continuous wetting conditions for cases (a), (b), (c), (d), and (e).

Fig. 4 presents the test series under continuous wetting conditions for cases (a) to (e). Six NaCl solutions were compared in all simulations: 26.4% (saturated concentration), 20.0%, 15.0%, 10.0%, 3.0%, and 0.1% (based on field measurements).

During the first month, external water infiltrates the concrete surface, rapidly increasing chloride concentration in the outermost layer. As exposure progresses, accumulation slows, reaching near-saturation after six months, after which chloride ions begin penetrating deeper, as observed in cases (c), (d), and (e). Case (c), corresponding to 12 months of exposure, closely replicates the chloride profiles measured in 2019, with the best fit obtained using a 10.0% NaCl solution.

This suggests that the tunnel, under continuous wetting, experienced prolonged exposure to external water with approximately 10% NaCl. Since chloride redistribution under drying conditions is very slow, it is reasonable to assume that the 2019 profile still retains characteristics of the 2009 exposure, supporting the hypothesis that chloride contamination was a sustained process over time.
